**BROOKVILLE LAKE
GREATER MIAMI RIVER BASIN
INDIANA**

**EMBANKMENT CRITERIA AND
PERFORMANCE REPORT**

**PREPARED BY
U.S. ARMY ENGINEER DISTRICT, LOUISVILLE
CORPS OF ENGINEERS**

SEPTEMBER 1982

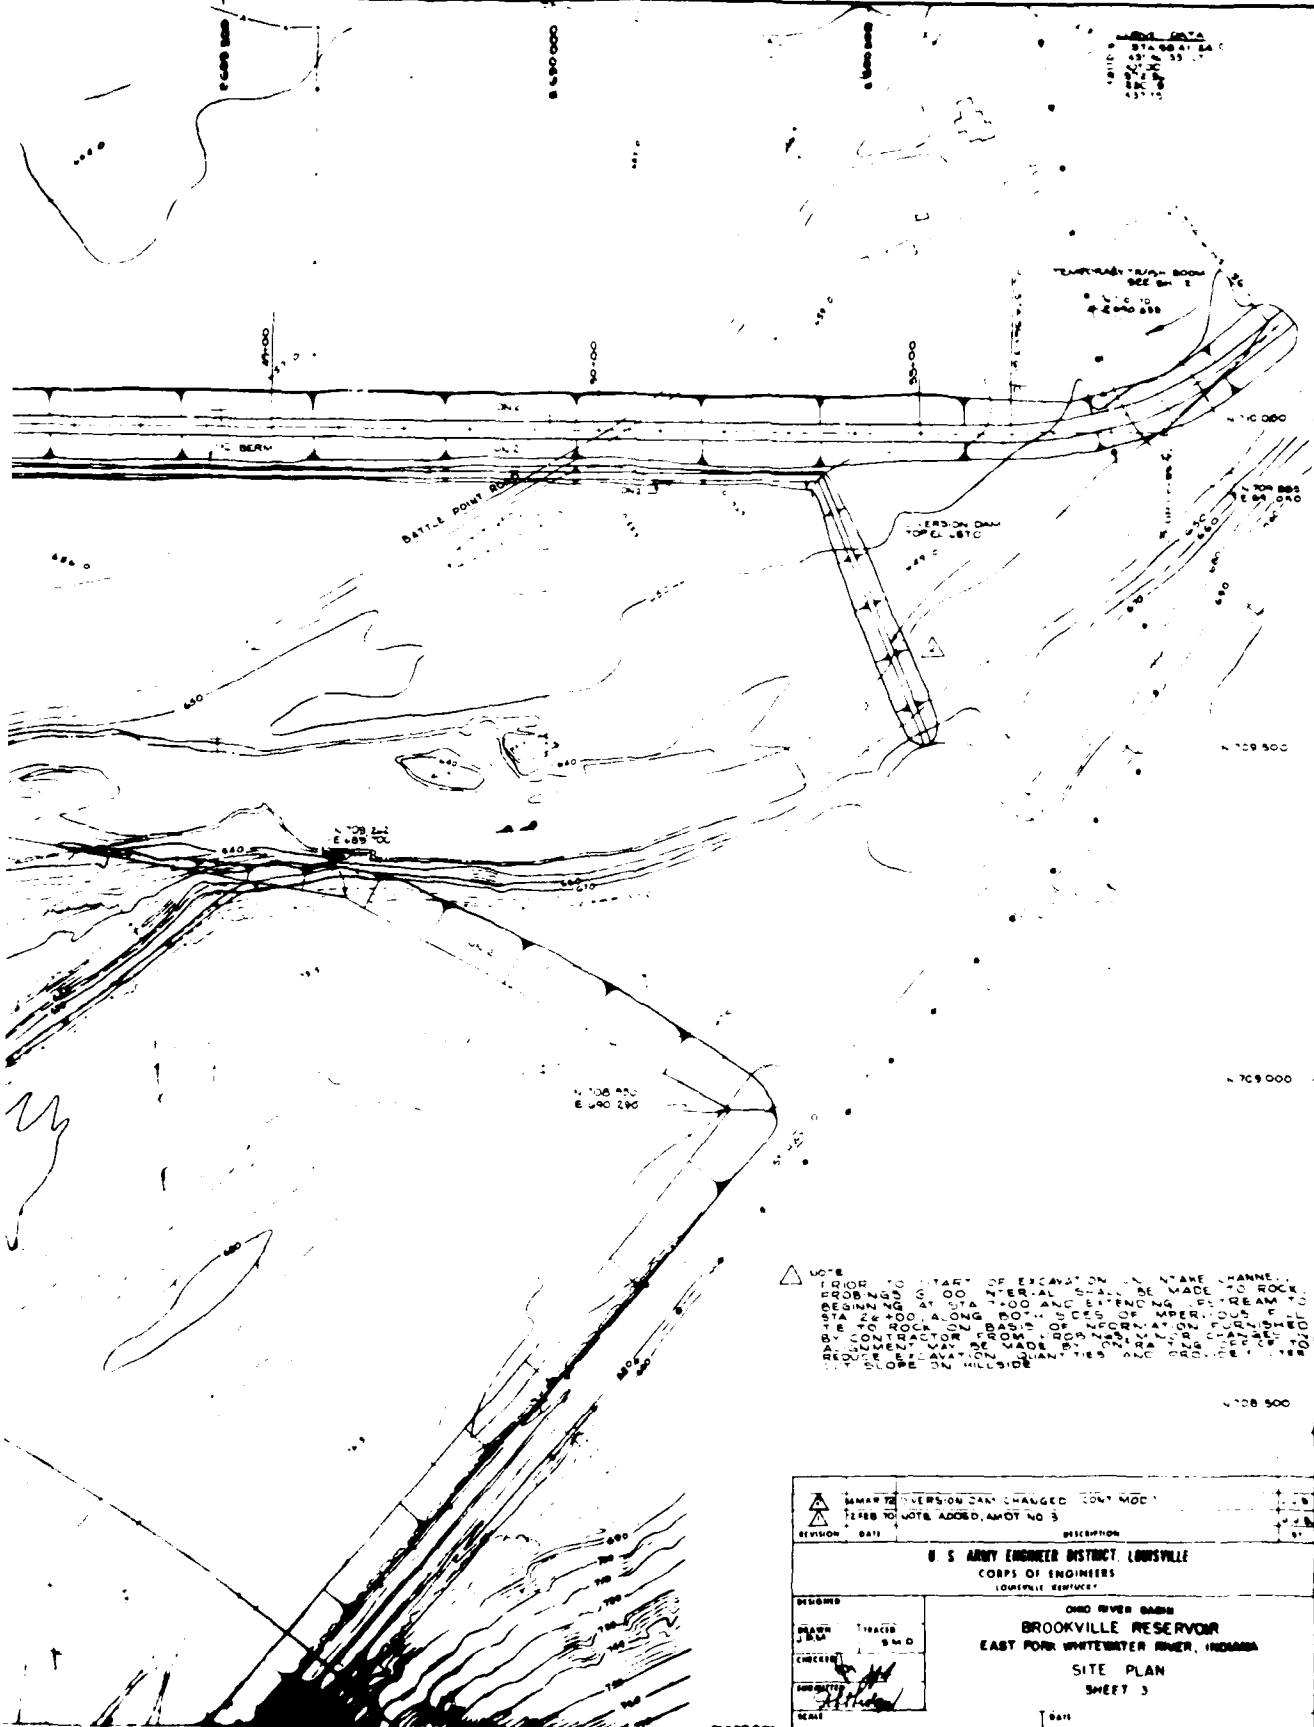
PLATE NO. 3

NOTE
PRIOR TO START OF EXCAVATION IN TAKE CHANNEL,
PROBING TO 10' DEPTH SHALL BE MADE TO ROCK
BEGINNING AT STA 1+00 AND EXTENDING UPSTREAM TO
STA 2+00 ALONG BOTH SIDES OF PREVIOUS FILL
TO ROCK ON BASIS OF INFORMATION FURNISHED
BY CONTRACTOR FROM PROSING. ANY CHANGES TO
ALIGNMENT MAY BE MADE BY CONTRACTOR TO
REDUCE EXCAVATION QUANTITIES AND PROVIDE BETTER
SLOPE ON HILLSIDE

REVISION DATE DESCRIPTION	
U S ARMY ENGINEER DISTRICT, LOUISVILLE CORPS OF ENGINEERS LOUISVILLE DISTRICT	
DESIGNED DRAWN CHECKED APPROVED	CHINA RIVER DAM BROOKVILLE RESERVOIR EAST FORK WHITEWATER RIVER, INDIANA SITE PLAN SHEET 3
SCALE DATE	DRAWING NUMBER EFW-22-12346

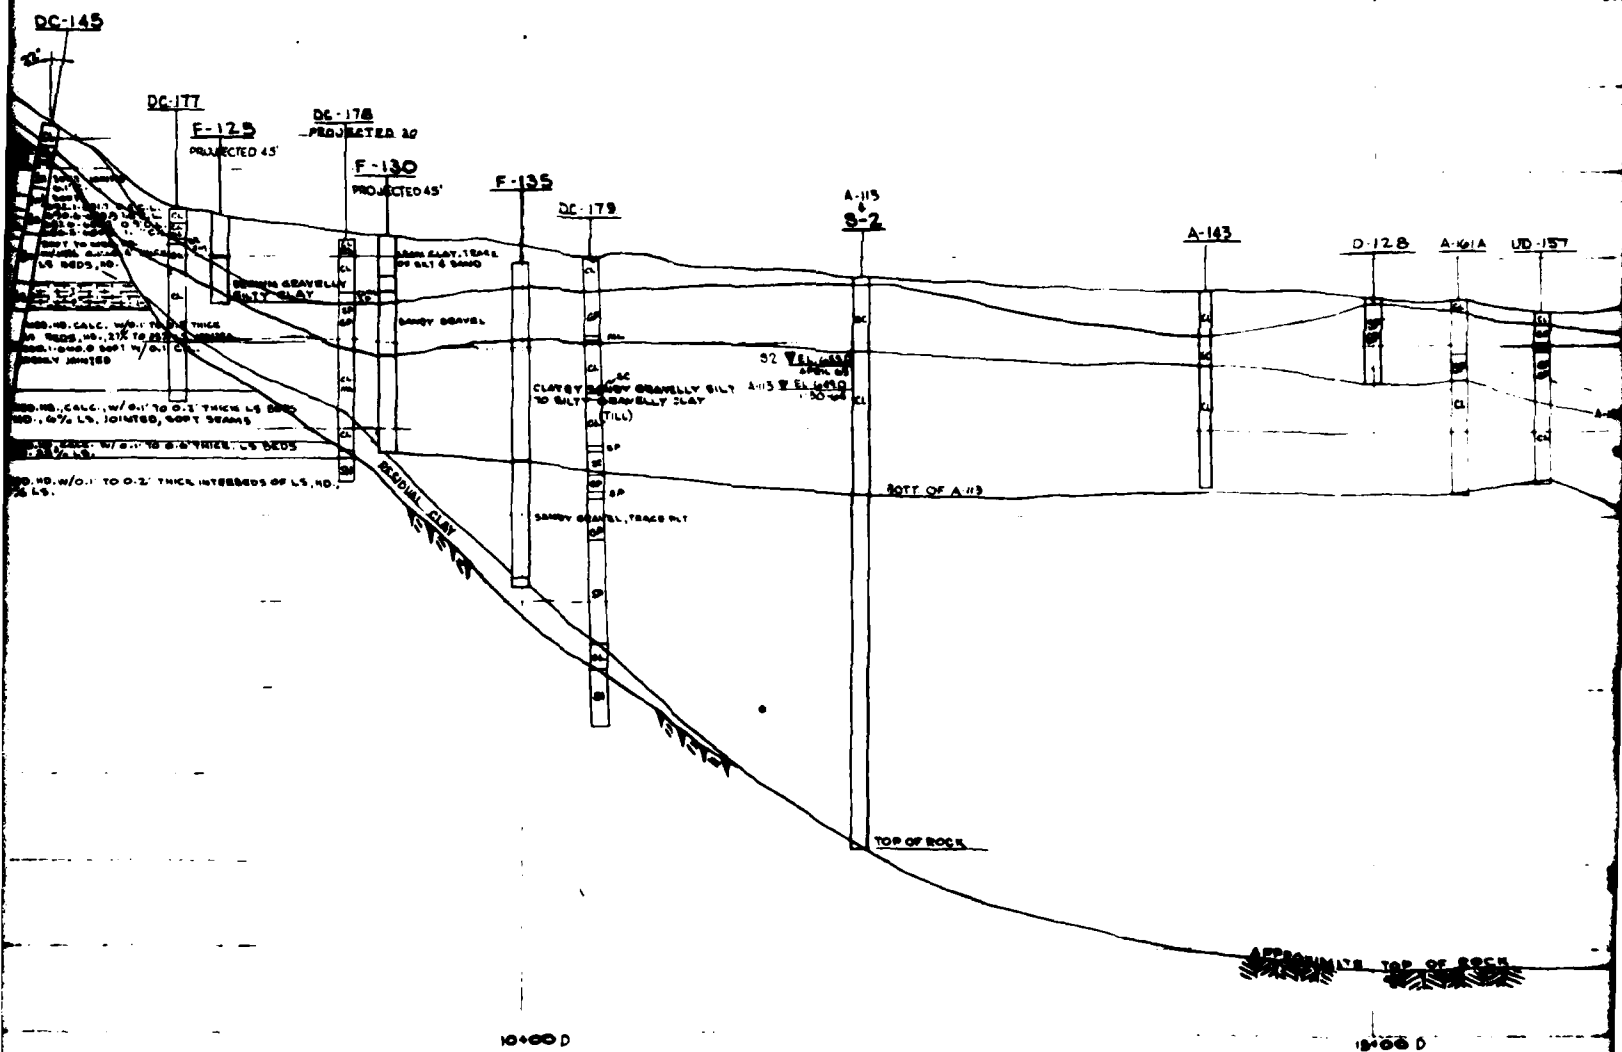
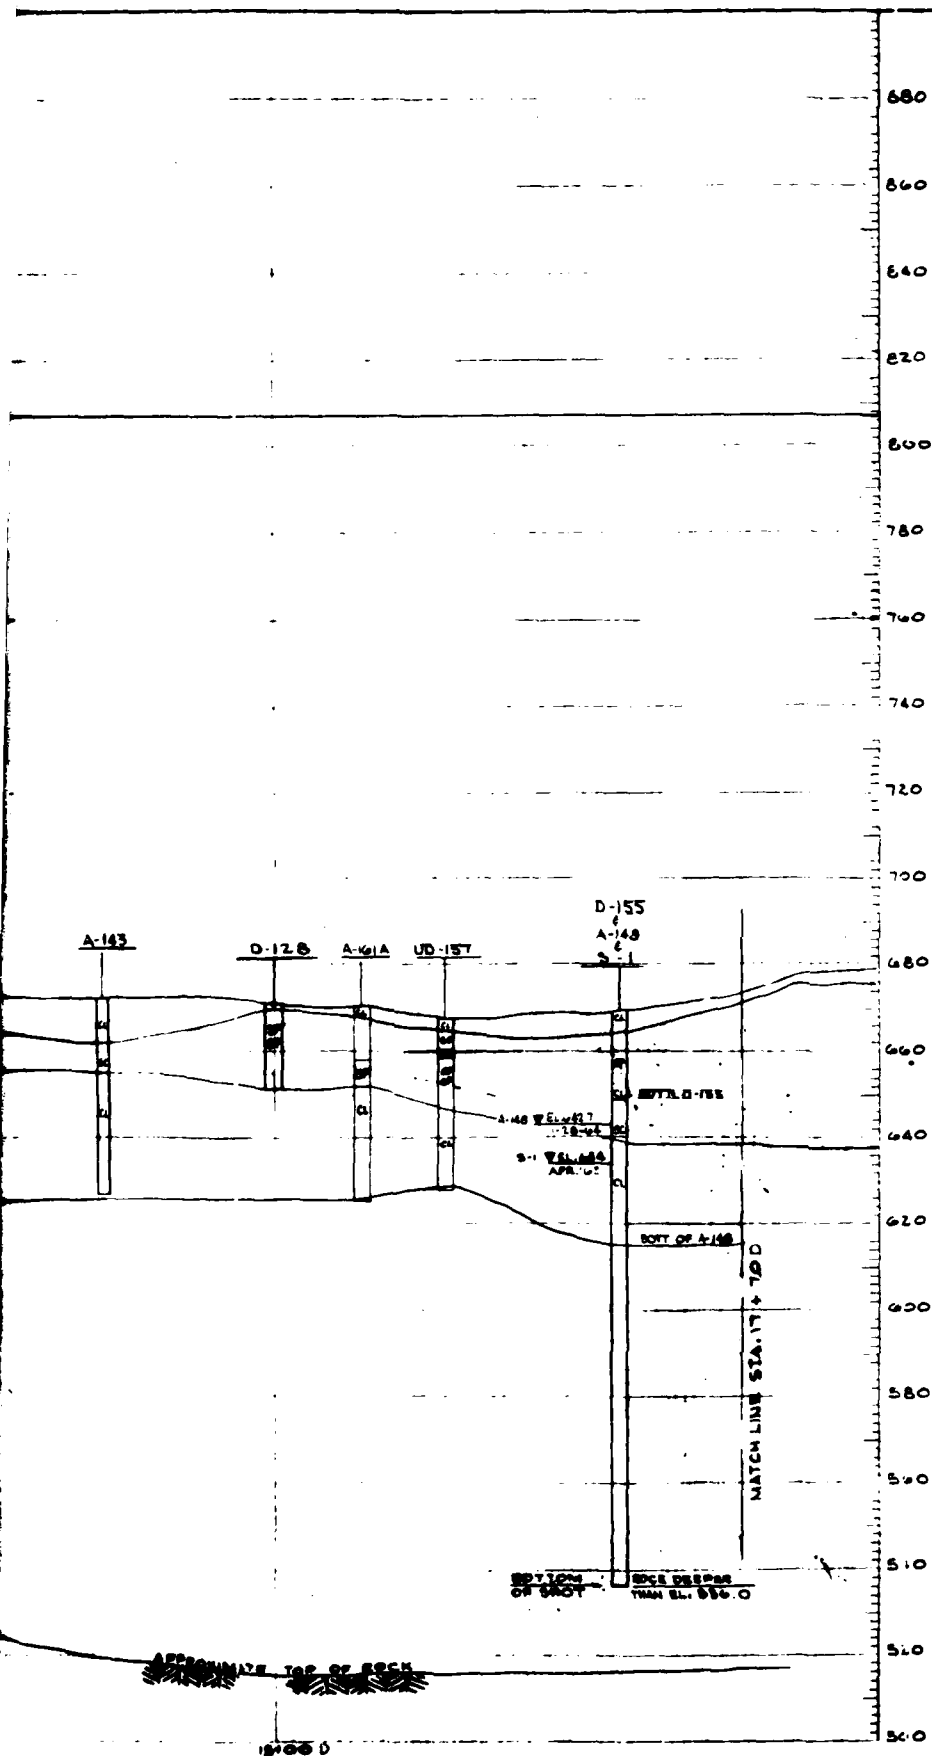
PLATE NO. 7

OHIO RIVER BASIN
BROOKVILLE RESERVOIR
EAST FORK WHITewater RIVER, INDIANA
GEOLOGIC PROFILE OF DAM

a. General. At the damsite, the valley walls stand on moderately steep slopes with shale only a few feet from the surface, as shown on the geologic profile of the dam, Plates 7 and 8. The right abutment slope is steeper than the left. The difference in slopes is due to the westward dip of the rock which dips from the left abutment to the right. The left abutment is 4 horizontal to 1 vertical and the right abutment slope is 3 horizontal to 1 vertical. The bottom lands are divisible into two parts, a flood plain roughly 15 feet above the river and a higher terrace at elevation 680, some 50 feet above the river. The bedrock profile drops off rapidly under the glacial outwash which has a thickness of 160 feet at its deepest point.

b. Valley Deposits. The 160 feet of valley deposits are essentially outwash sand and gravel with lenses of impervious clay till as shown on the geologic profile of the dam, Plates 7 and 8. Overlying bedrock is 110 feet of pervious sand and gravel with boulder and cobble size glacial erratics. Overlying the pervious sand and gravel is 20 to 30 feet of impervious silty gravelly clay till. The clay till is fairly uniform in thickness beneath the centerline of dam from the left abutment to the present flood plain, Station 21+50+. Top of till varies from elevation 640 to 660. Beneath the flood plain, the clay till has been eroded out by glacial melt waters and replaced by outwash sand and gravel.

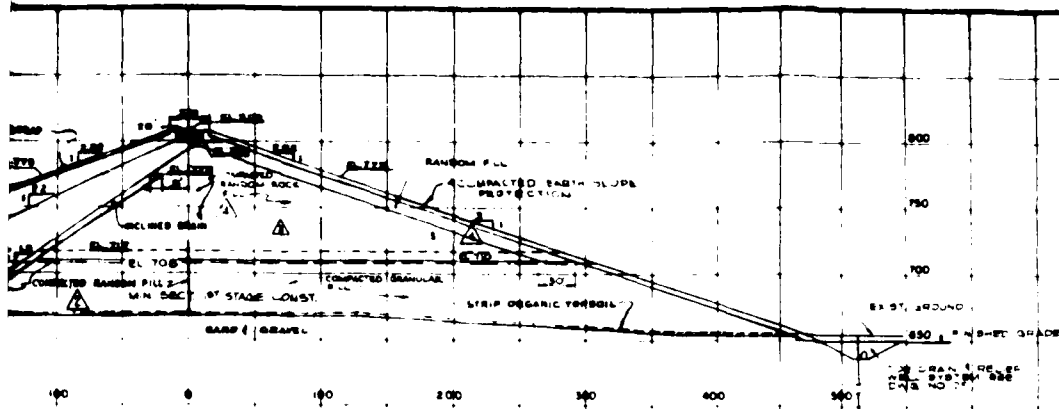
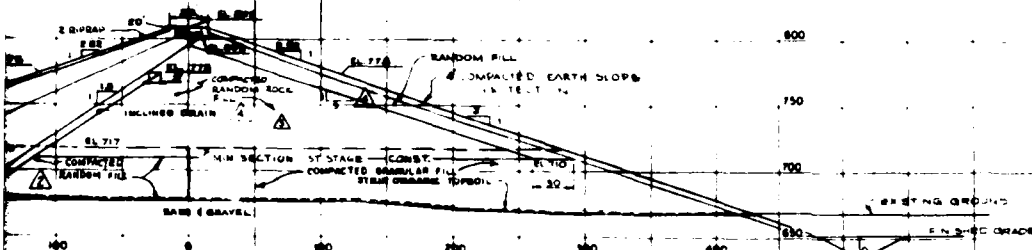
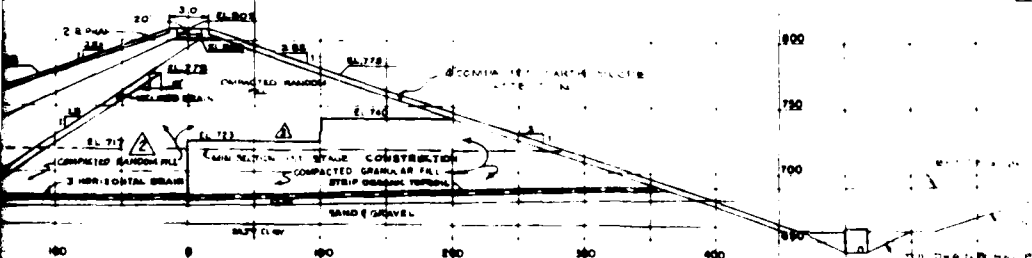
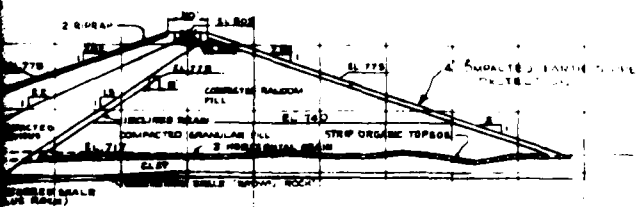
PLATE NO. 14

STA 21+00
(TYPICAL STA 20+00 TO STA 23+00)

STA 19+00
(TYPICAL STA 16+00 TO STA 20+00)

STA 10+00
(TYPICAL STA 8+25 TO STA 16+00)

STA 7+00
(TYPICAL STA 6+00 TO STA 8+25)

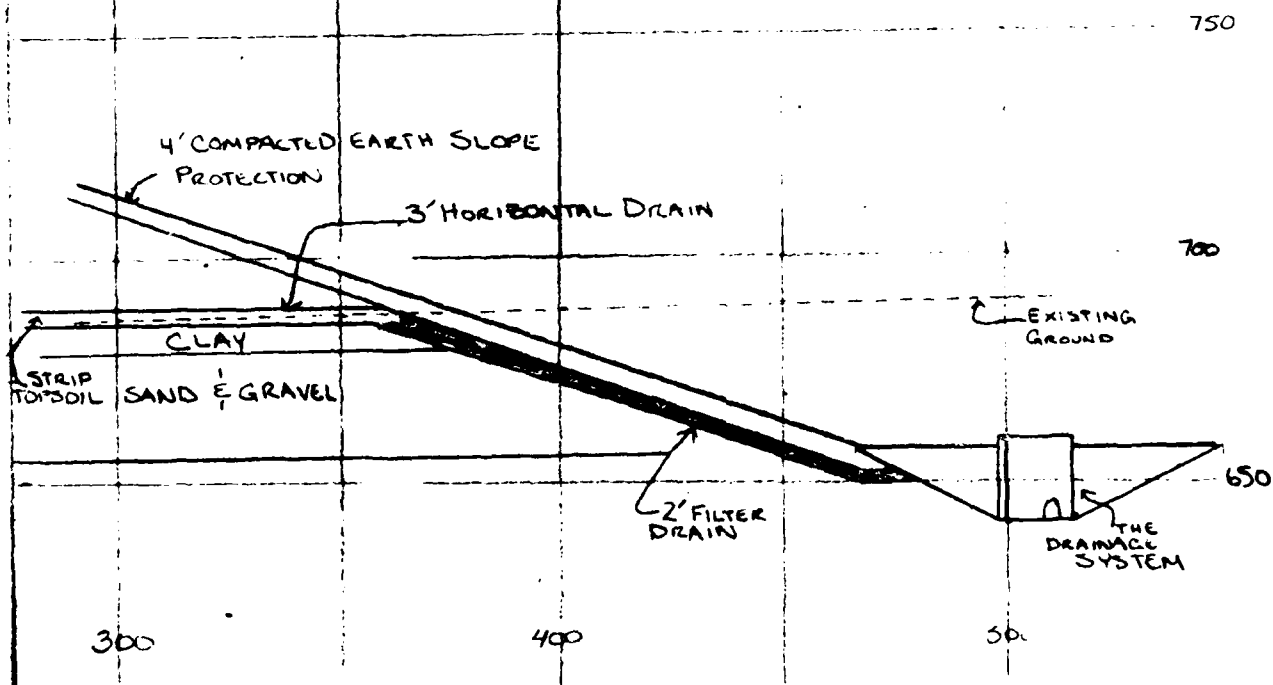
BROOKVILLE LAKE
 ADDITIONAL HORIZONTAL DRAINS
 SHEET 1 OF 2

TREATMENT BETWEEN 11+75-12+25

a. After the contract was awarded, a review of the contract plans ascertained that drainage from the 3-foot horizontal drain in the lower base of the dam was not adequately connected to the toe drainage system. Therefore, it was determined necessary to control the seepage outlet from the horizontal blanket and preclude the development of unsightly wet areas at the downstream base of the embankment. Two 50-foot wide by 2-foot deep inclined connector drains were installed. One was installed between Stations 11+75 and 12+25. The other was installed at Stations 19+50 and 20+00. The design plan for this change is included in Plate No. 15A. This design change was accomplished by Mod. No. 7.

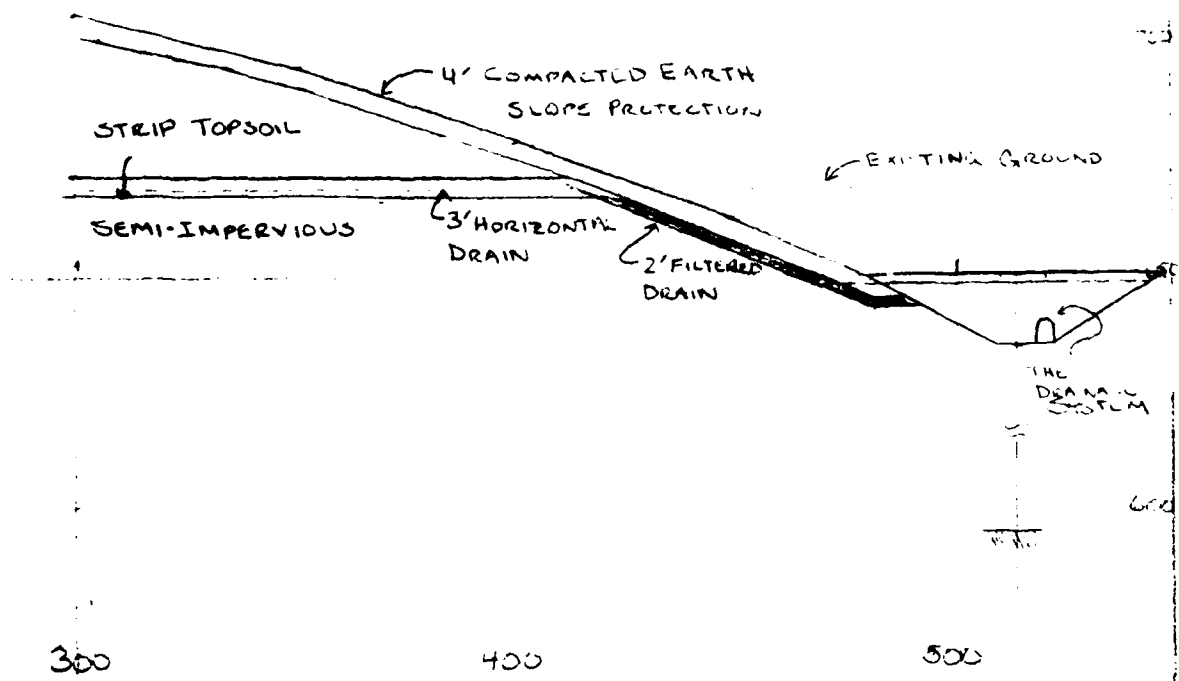
BROOKVILLE LAKE
ADDITIONAL HORIZONTAL DRAINS
SHEET 2 OF 2

TREATMENT BETWEEN 19+50 - 20+00

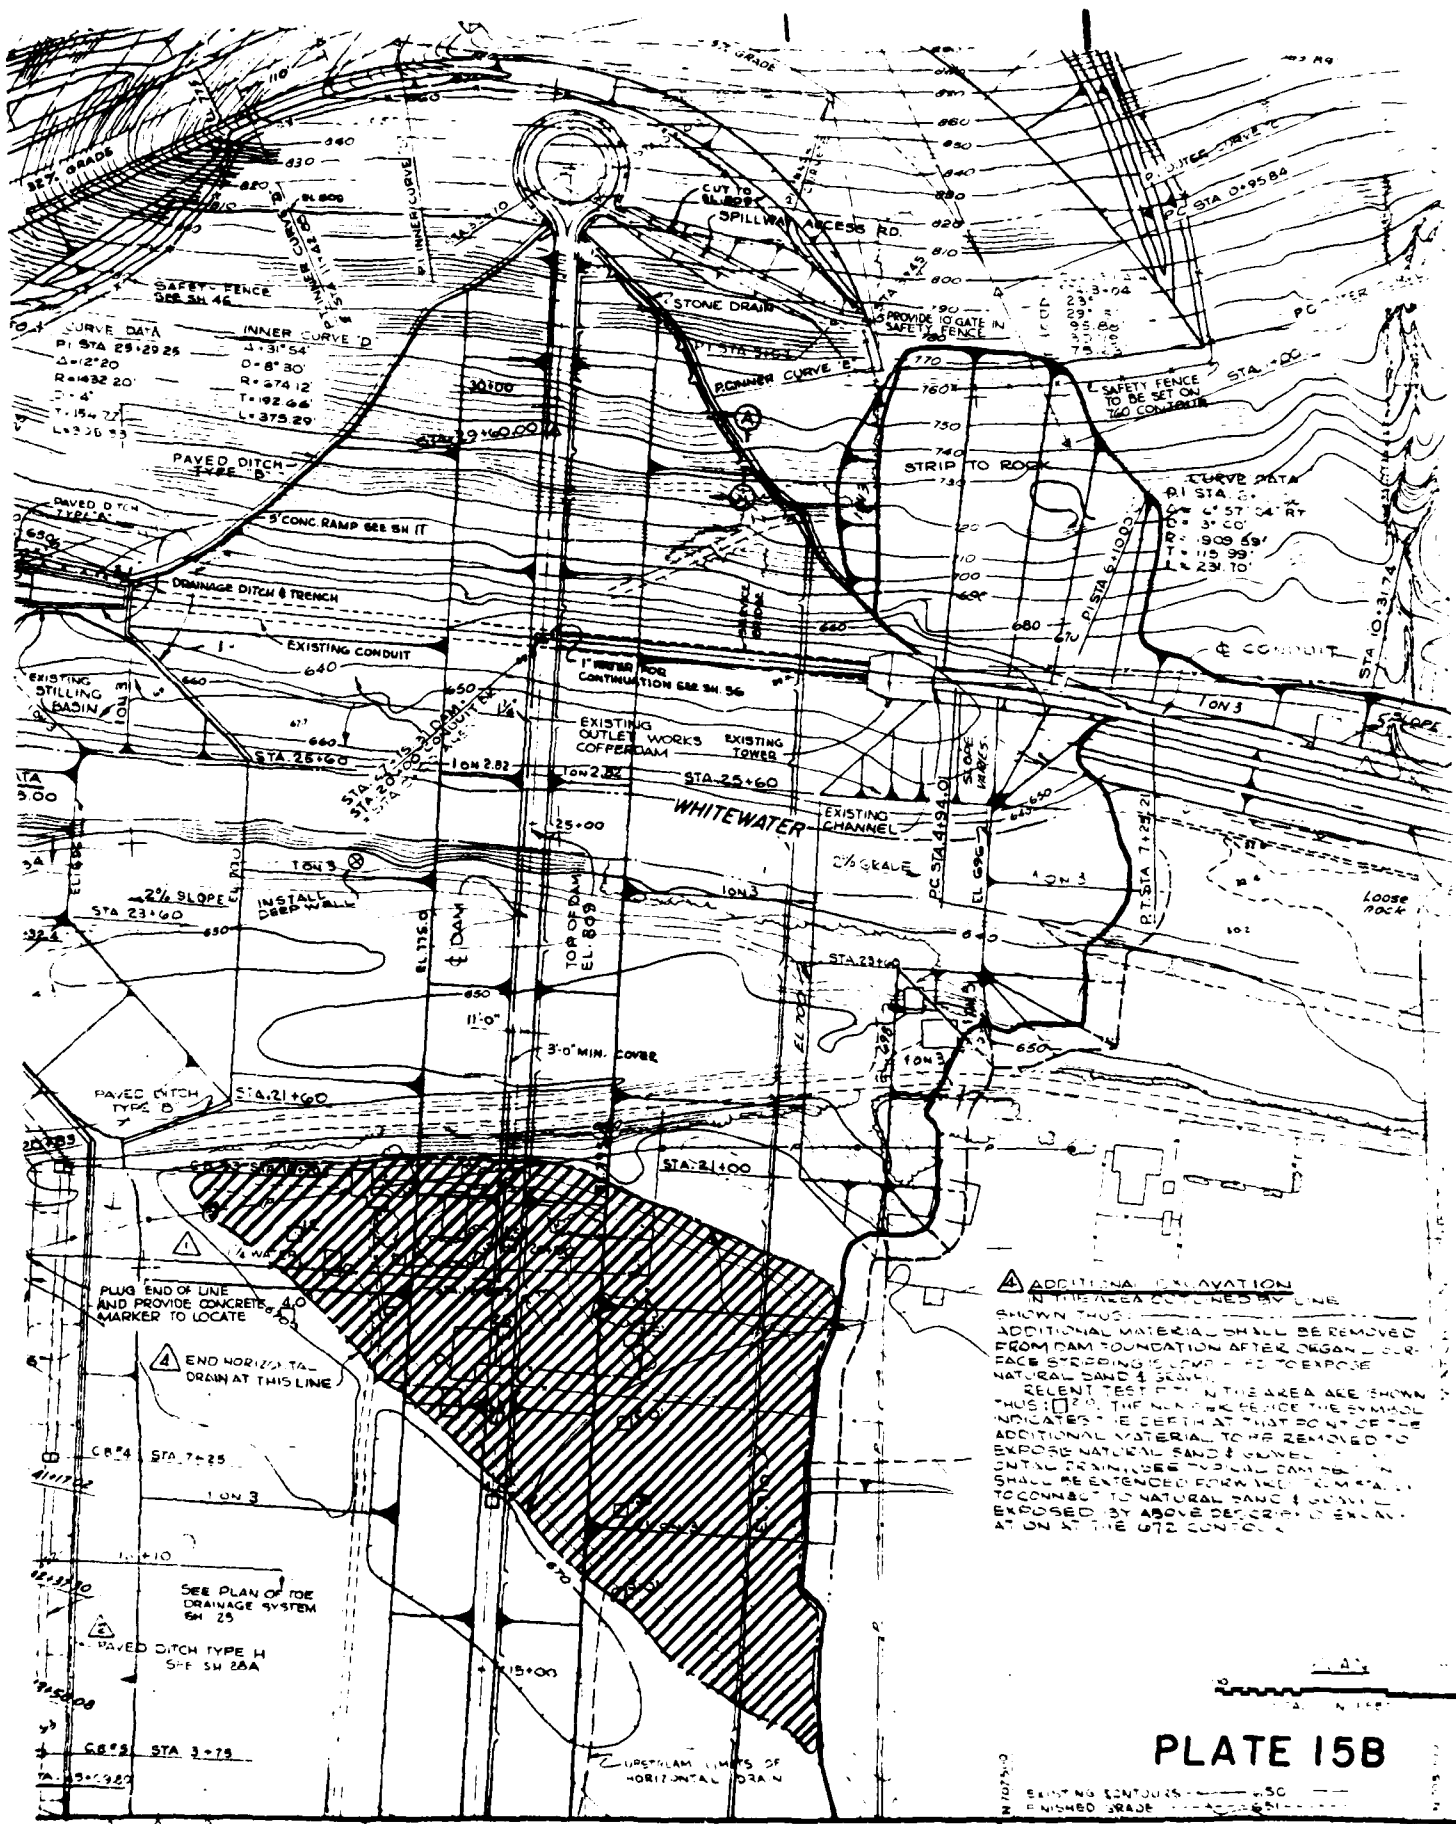
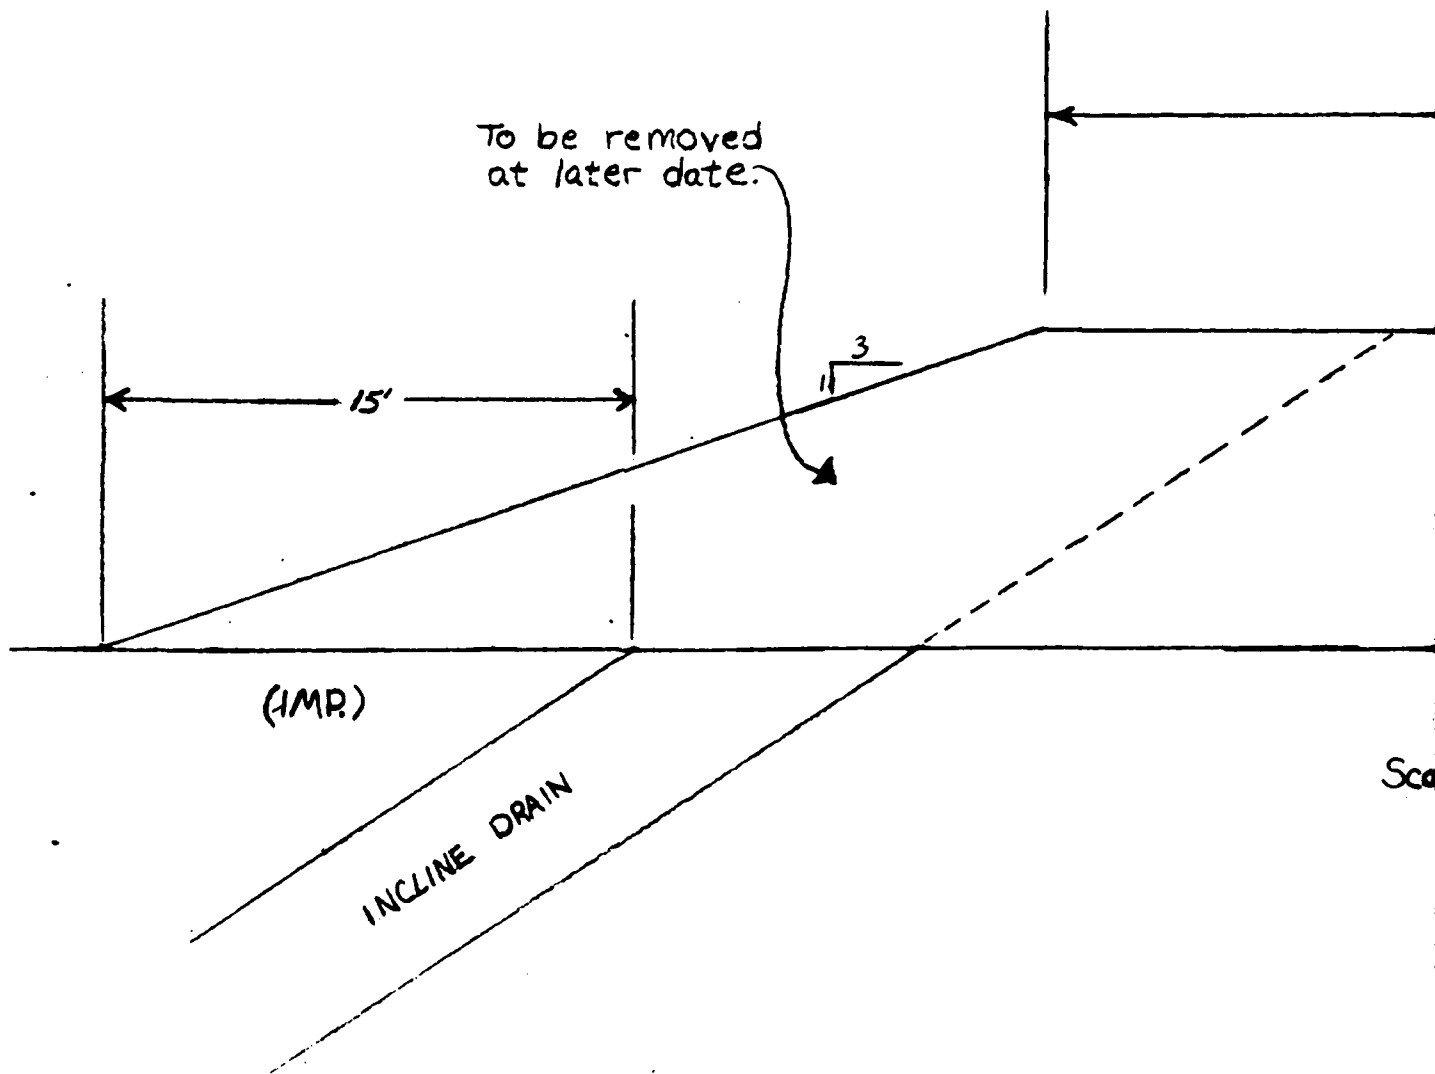
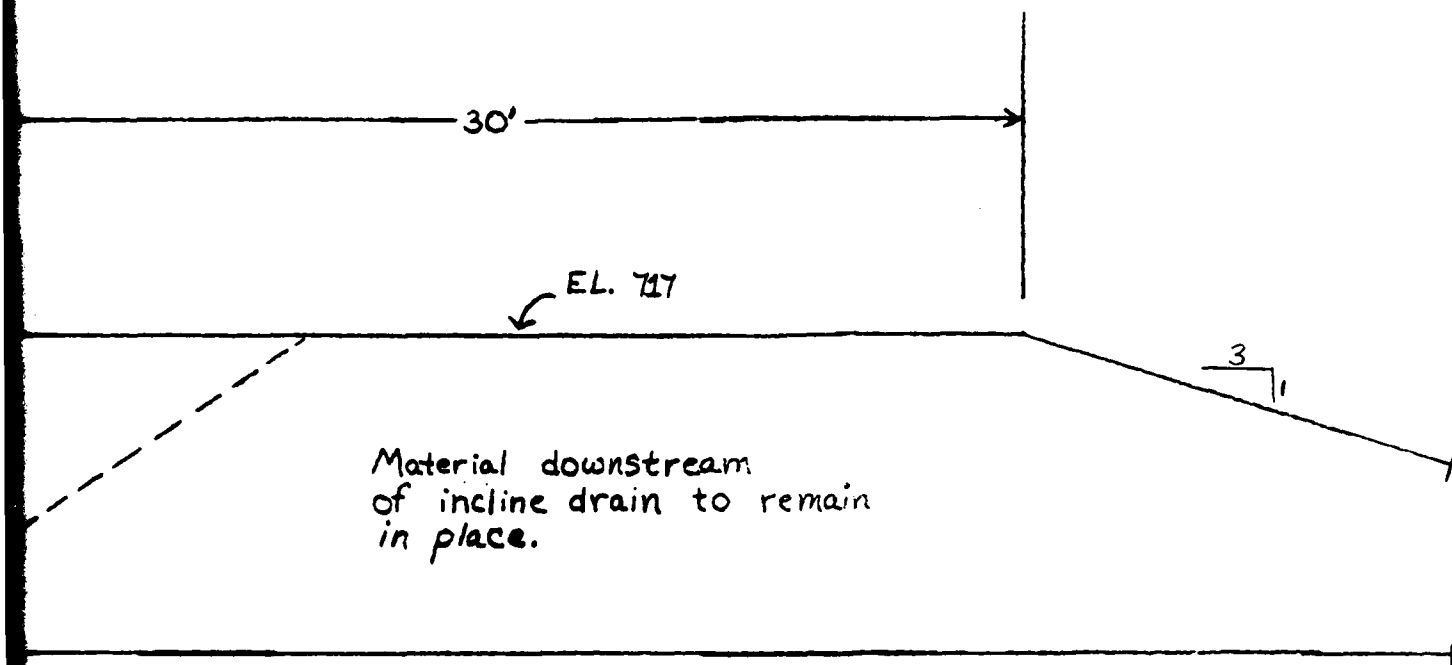
Plate 15C

Upstream toe of dike is to be a minimum of 15 ft. upstream of upstream edge of the incline drain and constructed on a 3 on 1 slope to a minimum elev. of 717.

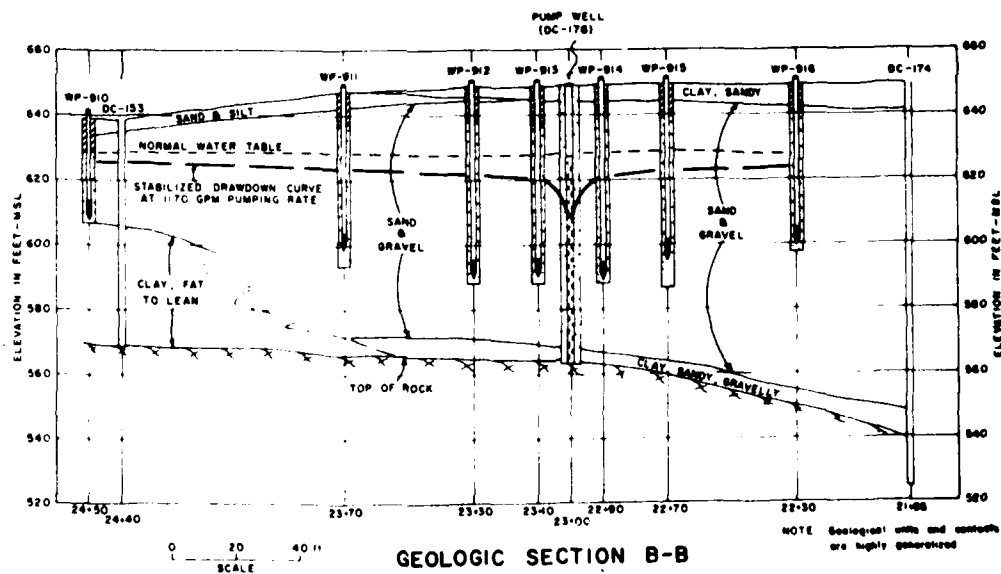
GEOLOGIC SECTION B-B

UPSTREAM TOE OF DAM

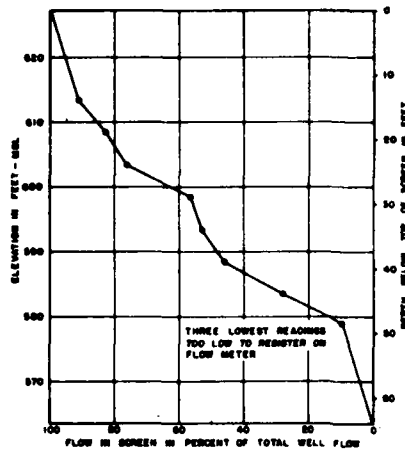
FLOW IN WELL AT VARIOUS DEPTHS
IN PERCENT OF TOTAL FLOW

PUMP WELL
(SAMPLE LOG SC-176)

A pumping test was made to determine a field value of the overburden permeability to use in underseepage calculations. The test was located on the left bank flood plain near the river as shown on Plate 16. It was concluded that maximum underseepage would occur in this area where there was no natural blanket of near-impervius material. Seventeen piezometers were drilled 10 to 310 feet from a pump well and the piezometers were set to depths indicated on Plate 16. Details of a typical piezometer are shown on Plate 17. All piezometers were set without the use of drilling mud. The holes were kept open by either continuous water circulation or the use of casing which was pulled as gravel packing was poured around the well point and pipe.

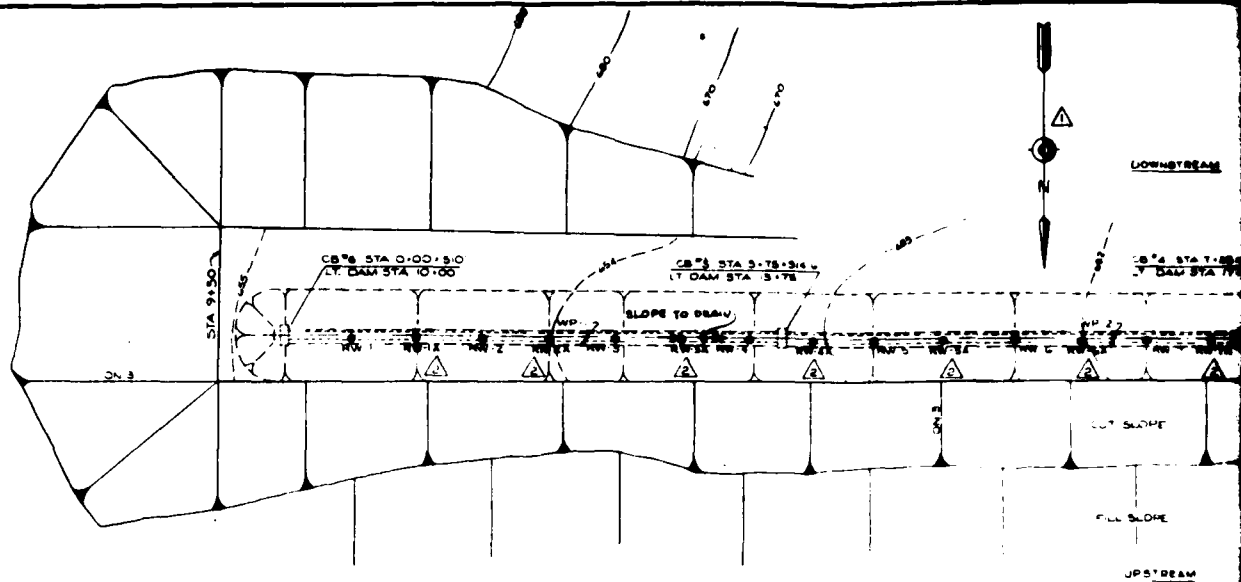
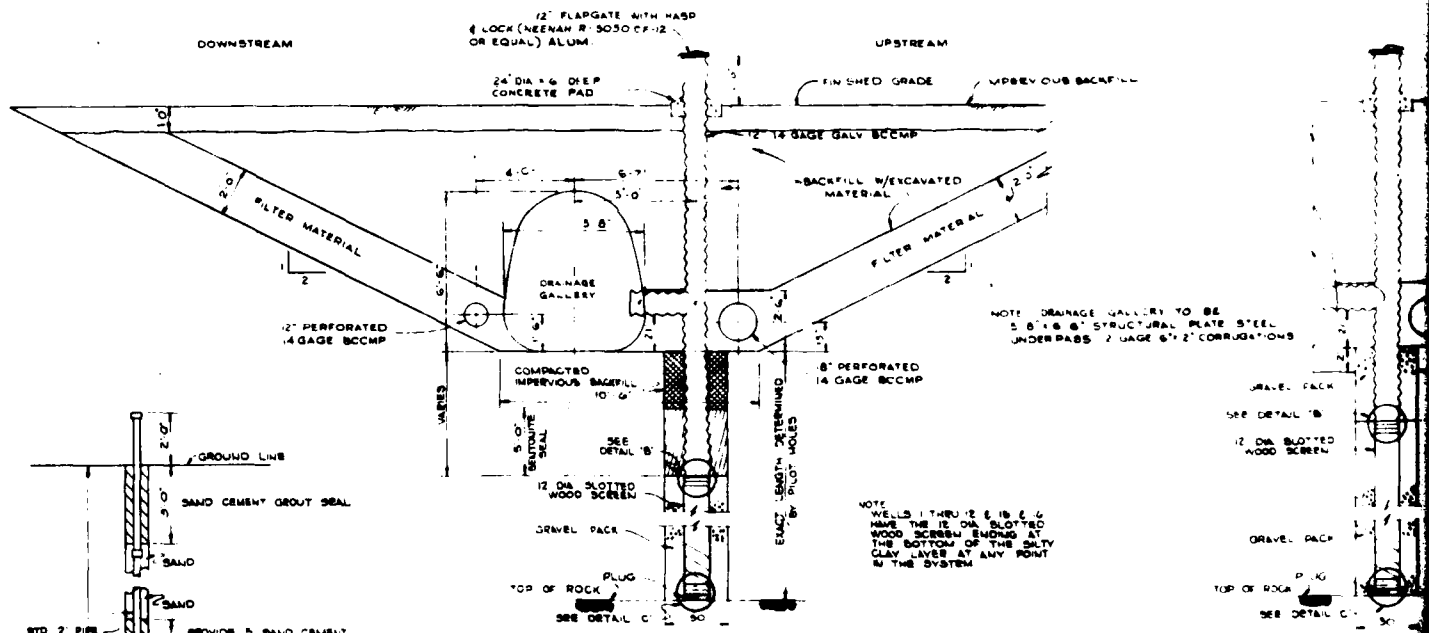
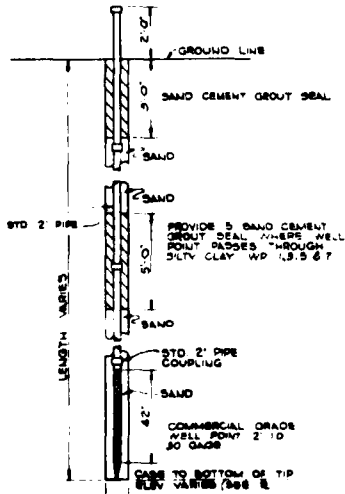
WELL POINT DETAIL
SCALE: 1"=20'

TYPICAL SECTION - WELLS 1 THRU 12, 6, 15 & 16
SCALE: 1"=10'

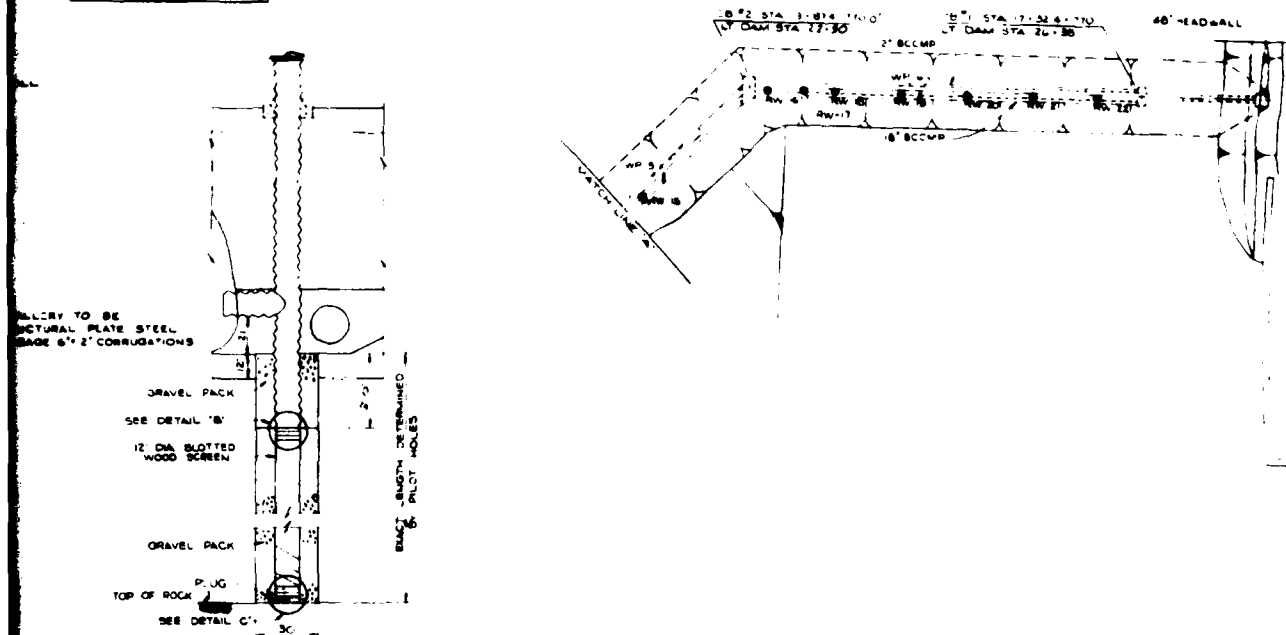
TYPICAL SECTION - WELLS 3, 4 & 7 THRU 22
SCALE 1/4" = 1' 0"

2" HUCK BOLT BLIND RIVETS WITH
5" HEAD OR EQUIV. SPACED 18"
ABOVE SHOULDER OF MORTISE (NO 12")
R. RECOMMENDED FOR WOOD TO WOOD
JOINT

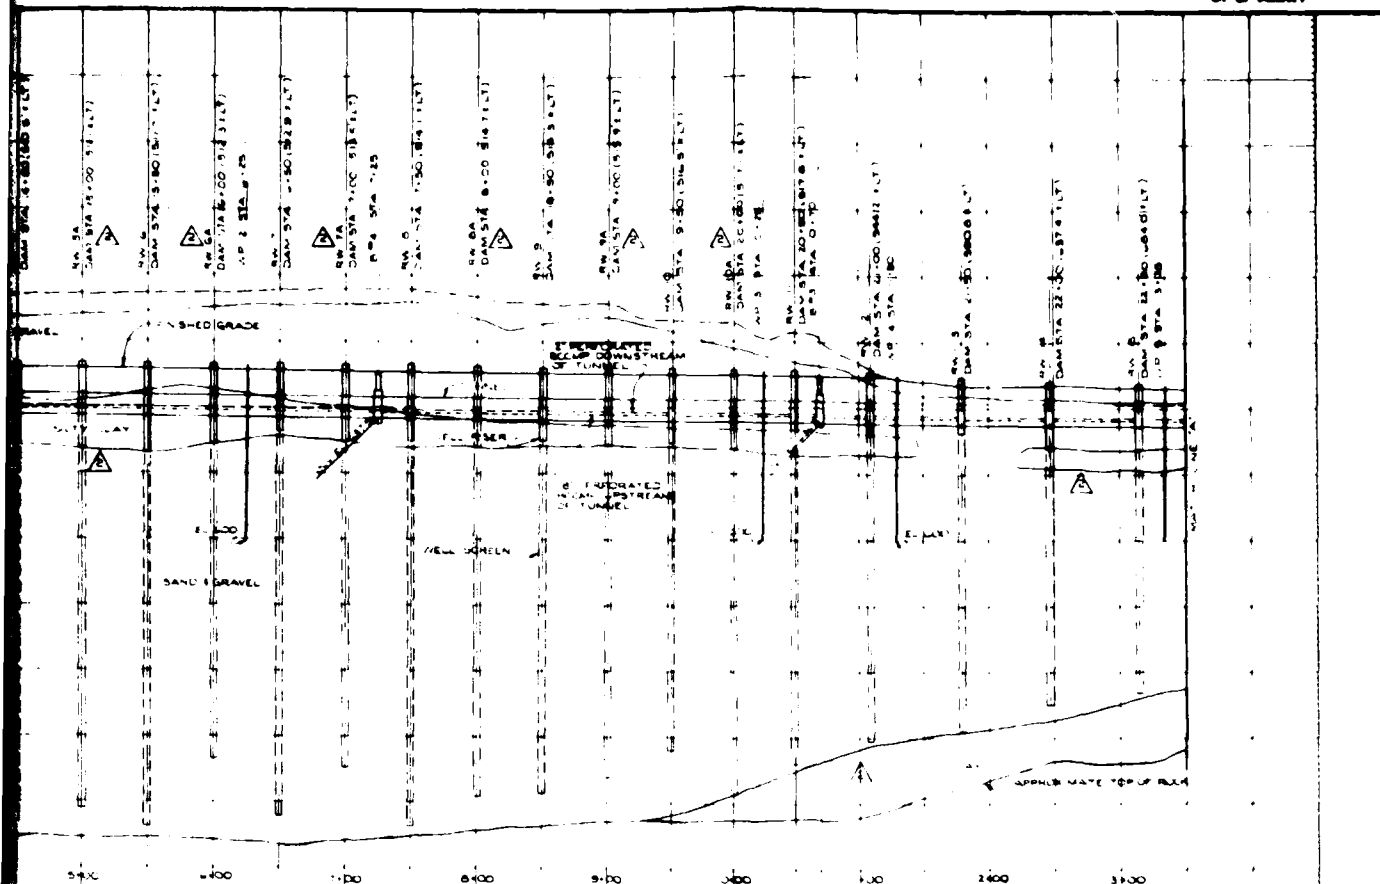
1. TITLE 2. PROJECT 3. DRAWING NO. (LASTED 1-1-60)		4. DATE 5. DESCRIPTION	
U S ARMY ENGINEER DISTRICT LOUISVILLE CORPS OF ENGINEERS LOUISVILLE DISTRICT			
DESIGNED DRAWN CHECKED SUBMITTED SCALE AS SHOWN		OMO RIVER BASIN BROOKVILLE RESERVOIR EAST FORK WHITE WATER RIVER, INDIANA TOE DRAINAGE SYSTEM PROFILE	
PLATE NO. 19		DRAWING NUMBER EFW-2 2-12/3/26
